Alameda Clash Report

Jun 12, 2020

**ASU Alameda
Warehouse**

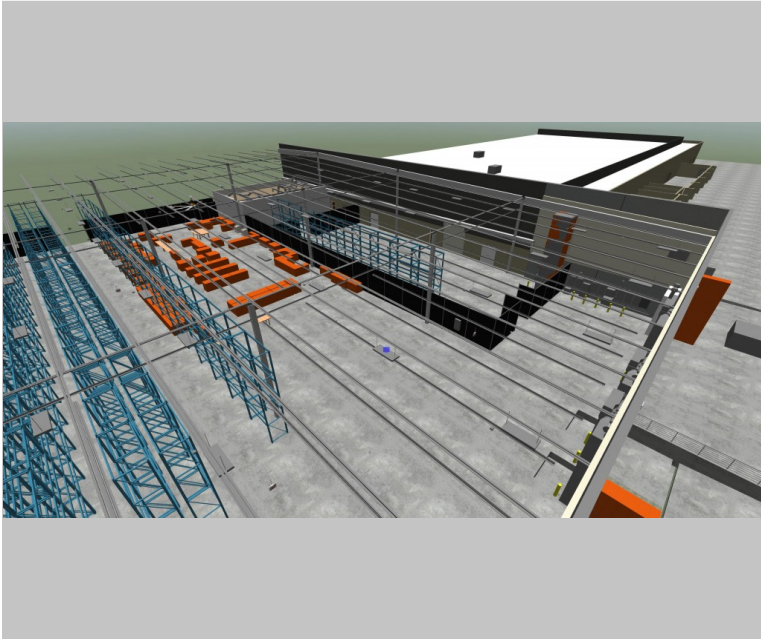
ID [1](#)

Title
staging area (194) Verify Light Layout and elevations(clashing with joists)

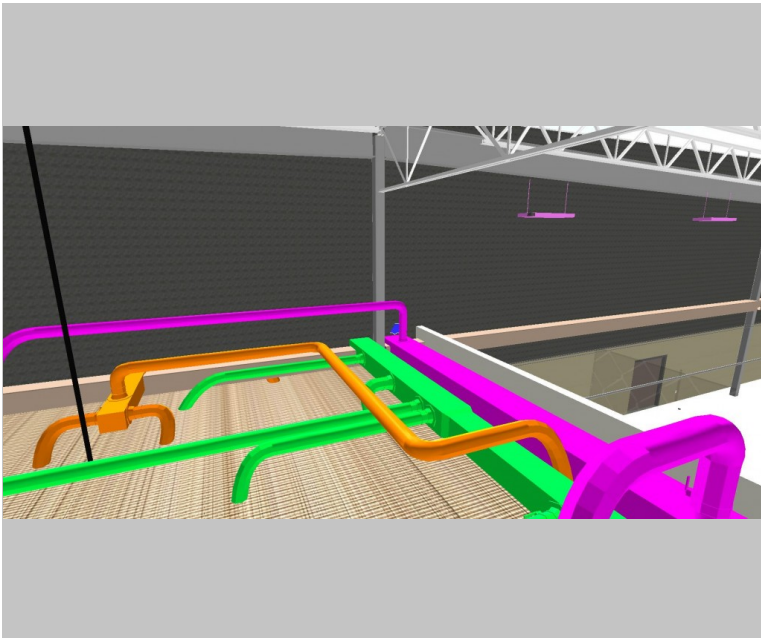
ID [2](#)

Title
men's restroom (111M1) Confirm Duct Penetration Locations to avoid Beam

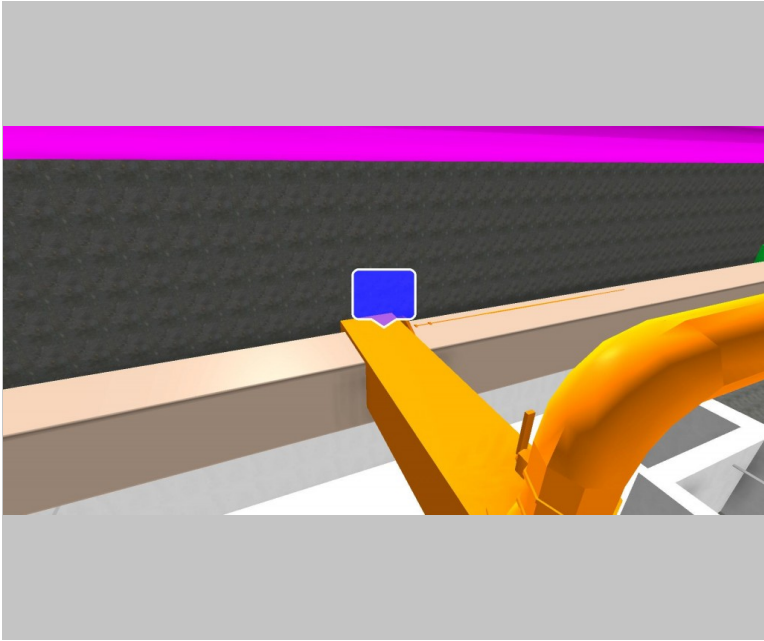
ID [3](#) None Open

Title
Access Control (113U1) Exhaust duct going through a beam, coordination needed

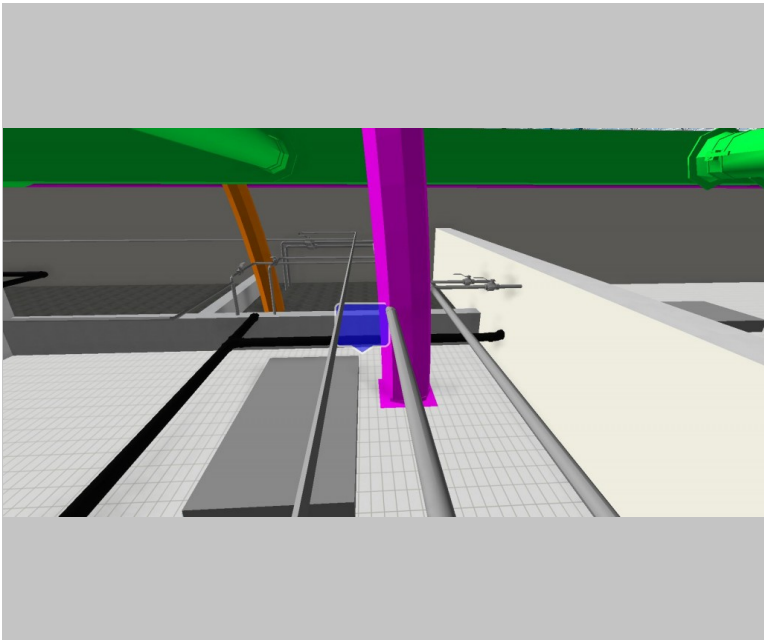
ID [4](#) None Open

Title
Lockers room(111V1) Return round duct clashing with domestic cold water pipe, positioned too close to the light fixture

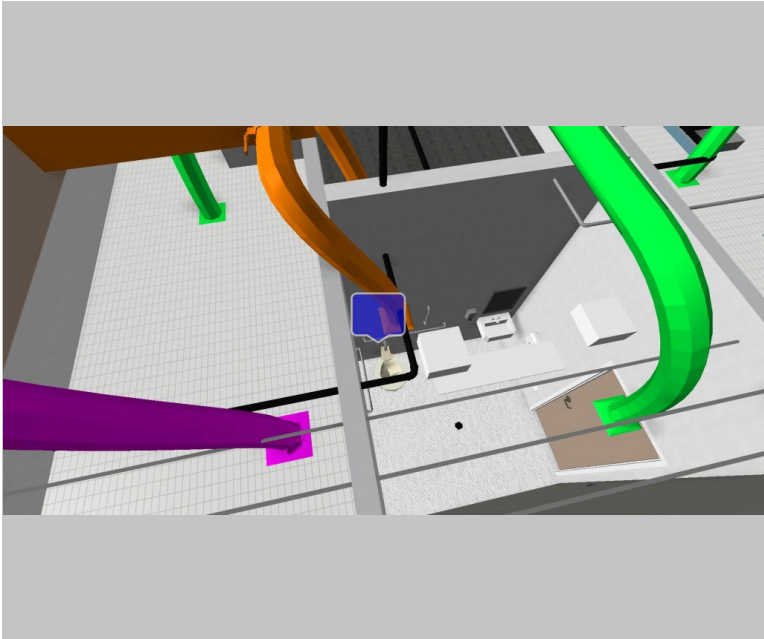
ID [5](#) None Open

Title
Women's restroom(111W1) Return and Exhaust duct clashing with sewer pipe and domestic cold water pipe respectively

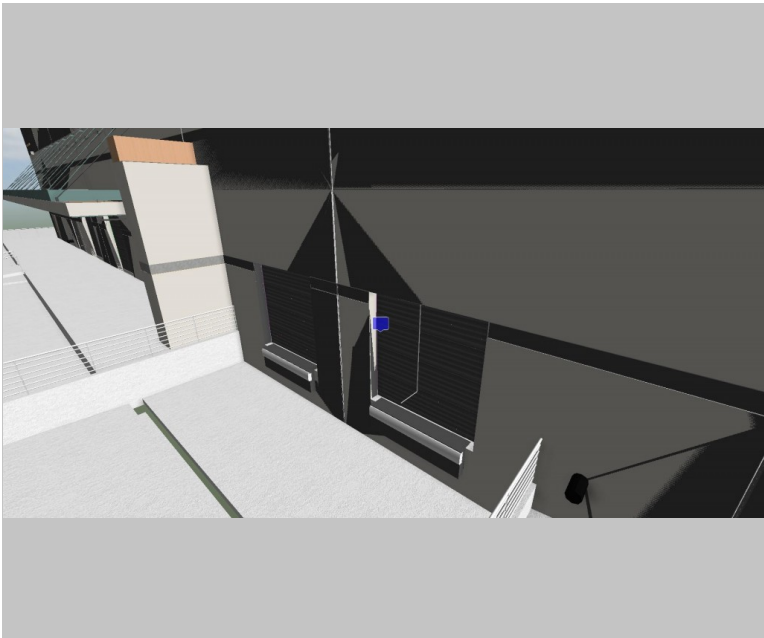
ID [6](#) None Open

Title
Receiving room (190) Hose bib located at rolling door (190c)/ pipe clashing with door

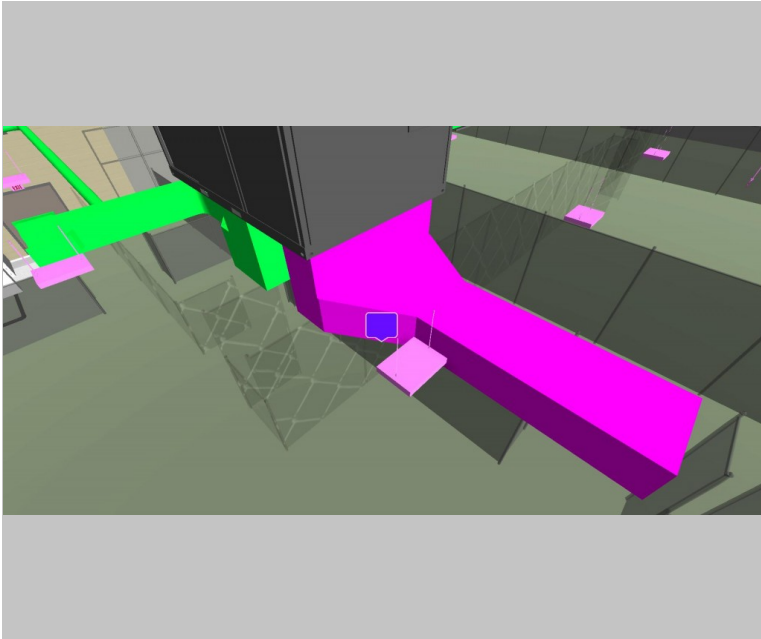
ID [7](#)

Title
Auction area(182) Light Fixture clashing with a return duct

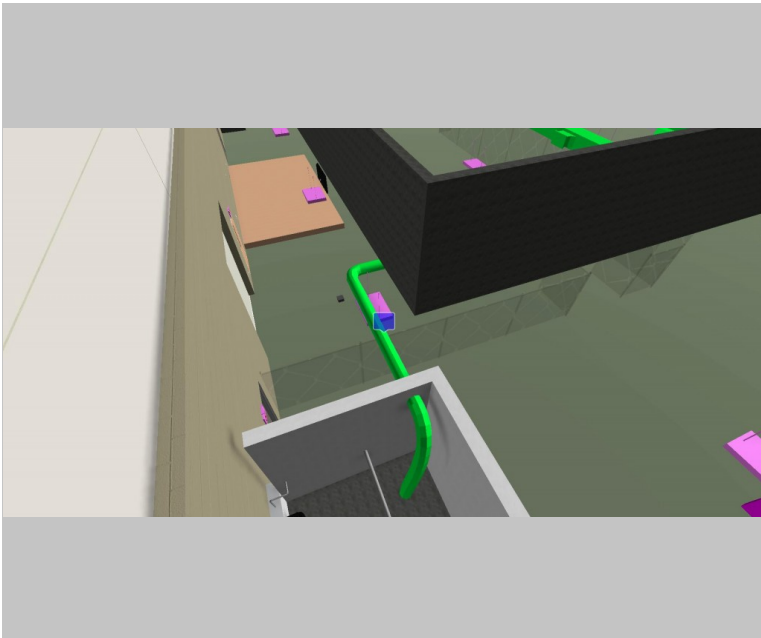
ID [8](#)

Title
Unisex restroom (180T) Light fixture clashing with a supply duct

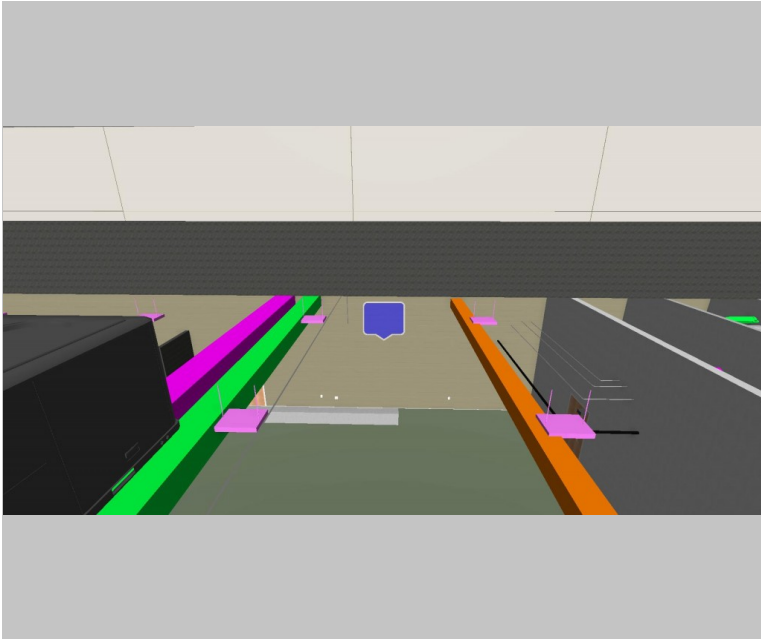
ID [9](#)

Title
Auction space(182) Multiple light fixtures clashing with return and exhaust ducts.

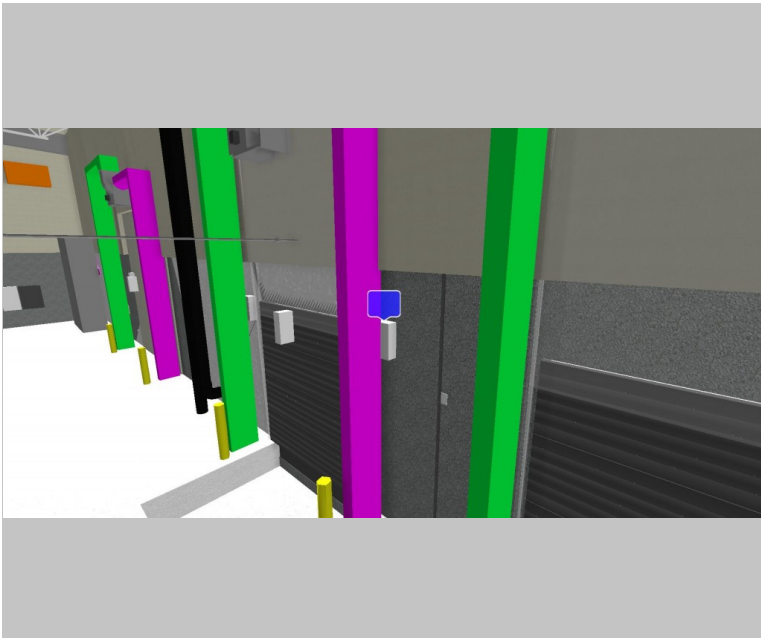
ID [10](#)

Title
Receiving area(190) near door 190D Electrical fixture clashing with a vertical return duct.

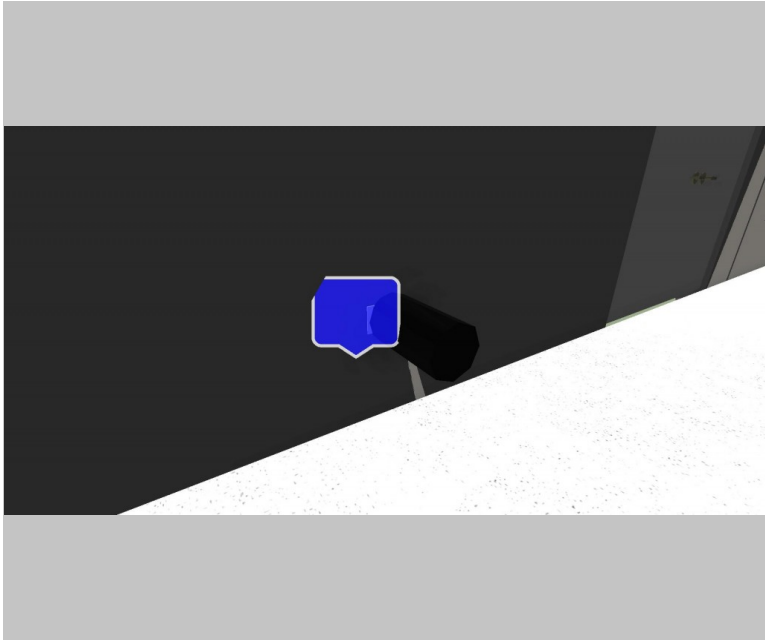
ID [13](#) None Open

Title
Maintenance/staging area (194) 8" Drainage pipe clashing with electrical fixture GFCI Duplex Receptacle.

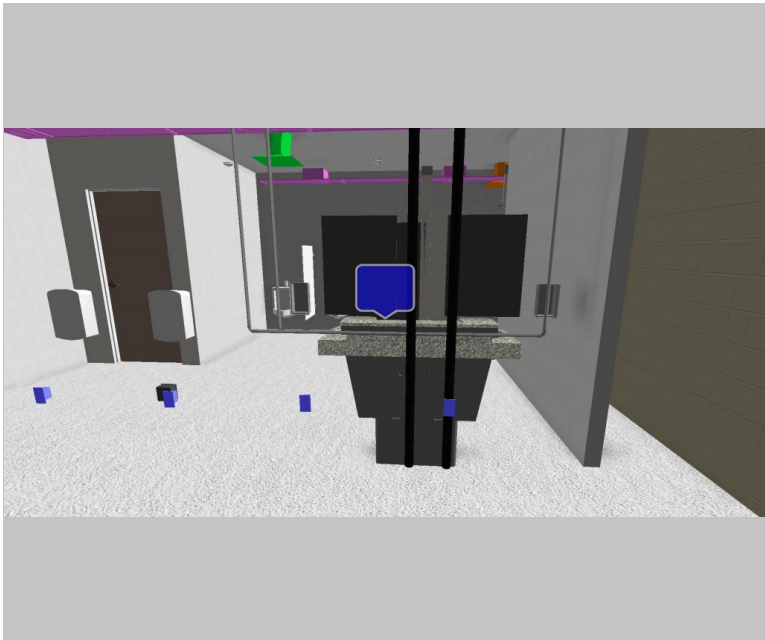
ID [14](#) None Open

Title
Tech area(191A) Electrical fixture clashing with 2" Sewer pipe.

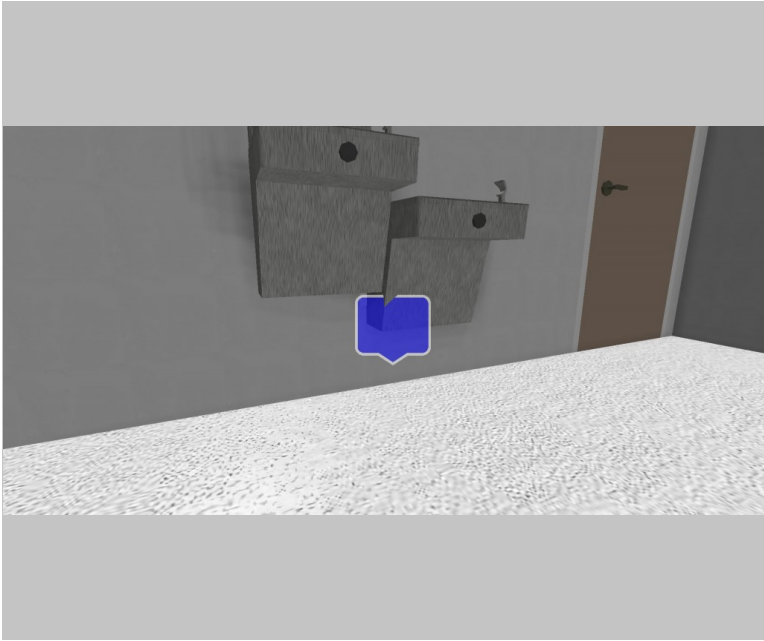
ID [15](#) None Open

Title
lockers area(111V1) Behind the two drinking fountains Electrical Fixture clashing with a 2" sewer pipe.

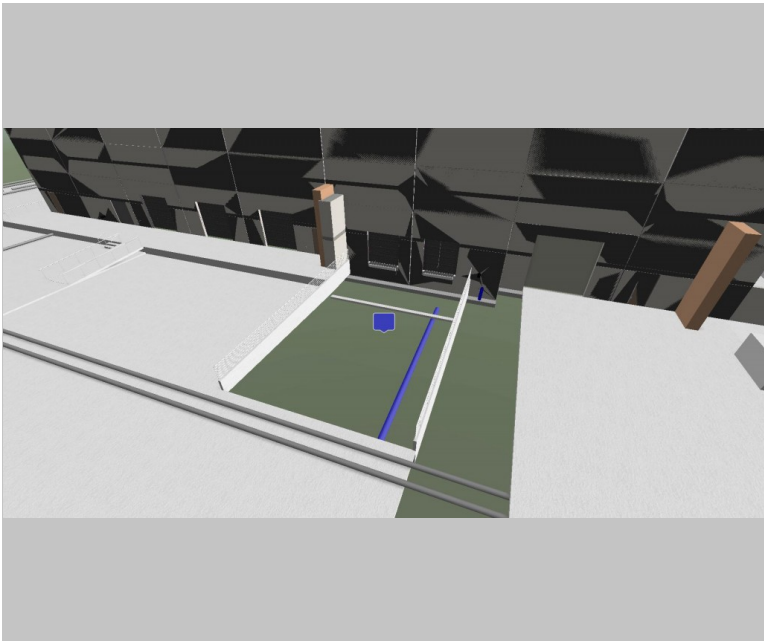
ID [18](#) None Open

Title
Loading dock-Receiving area (190) Miss alignment between underground drain storm location and drainage pipe coming from the roof.

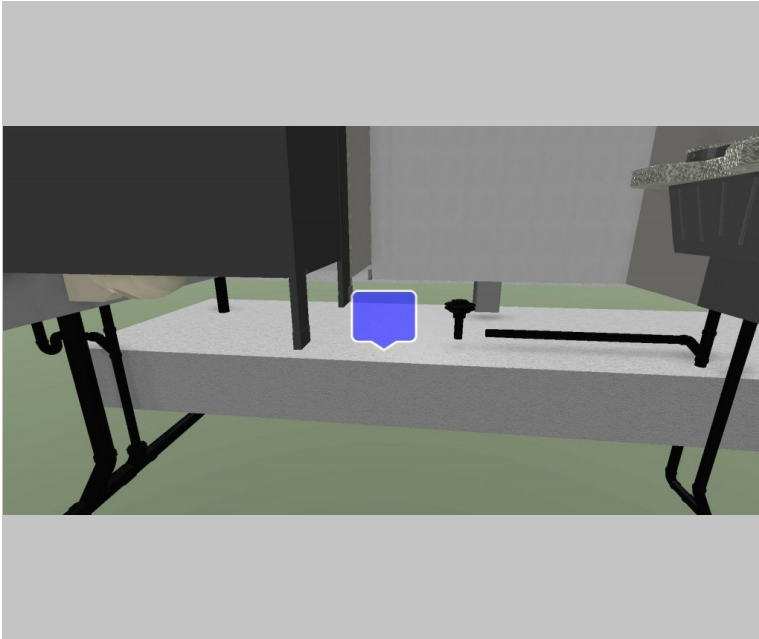
ID [19](#)

Title
Men's restroom (111M1) Multiple Sanitary pipes going through the footing.

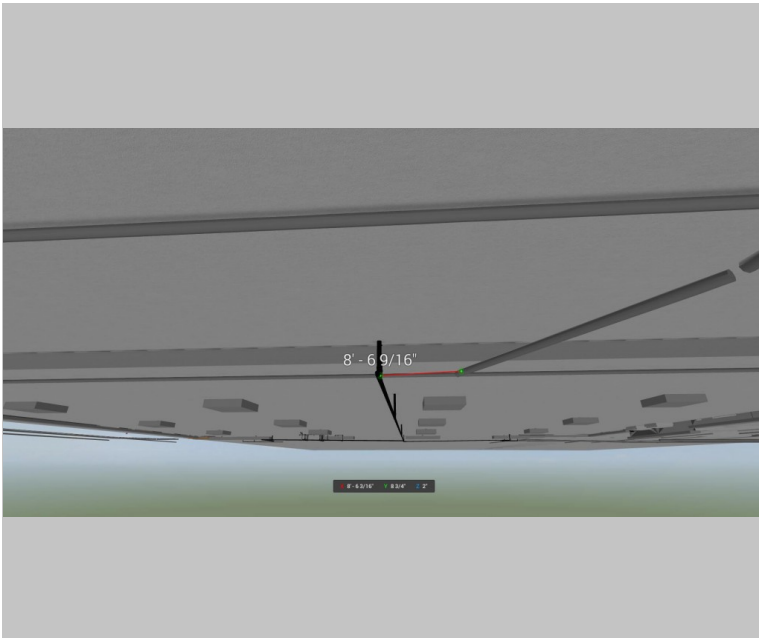
ID [20](#)

Title
Managed area (195) Sewer main pipe is miss aligned with sanitary pipe coming from the restrooms to the north of the building by 8' 6".

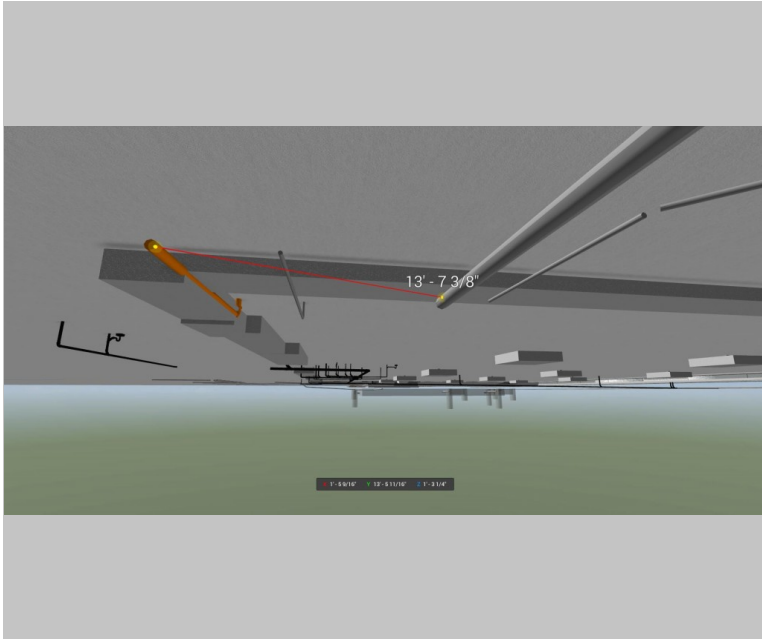
ID [21](#)

Title
East side, Self Managed area (104) Fire line pipe is not reaching the sprinklers main pipe, miss aligned by 13'6".

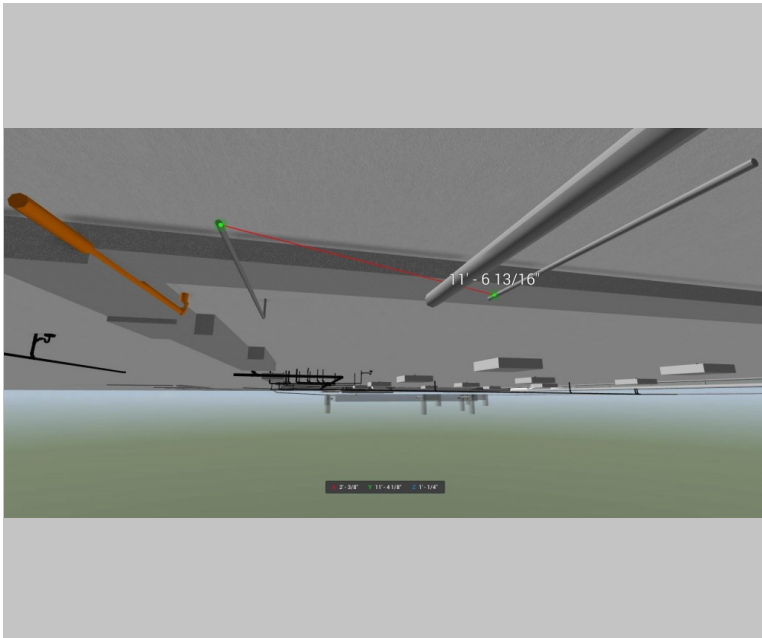
ID [22](#)

Title
Self Managed area(104) Domestic water pipe is miss aligned by 11'4".

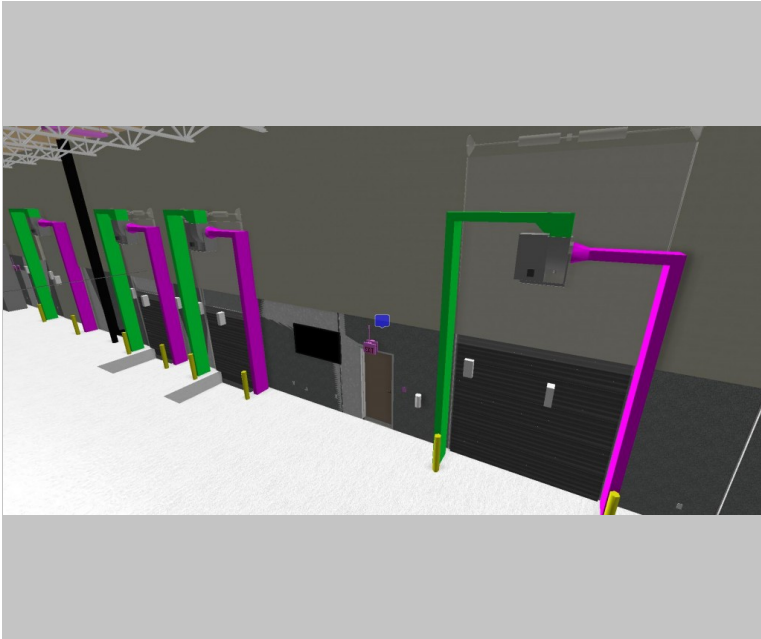
ID [23](#)

Title
Staging area(194) Verify duct work placement against rolling door railings

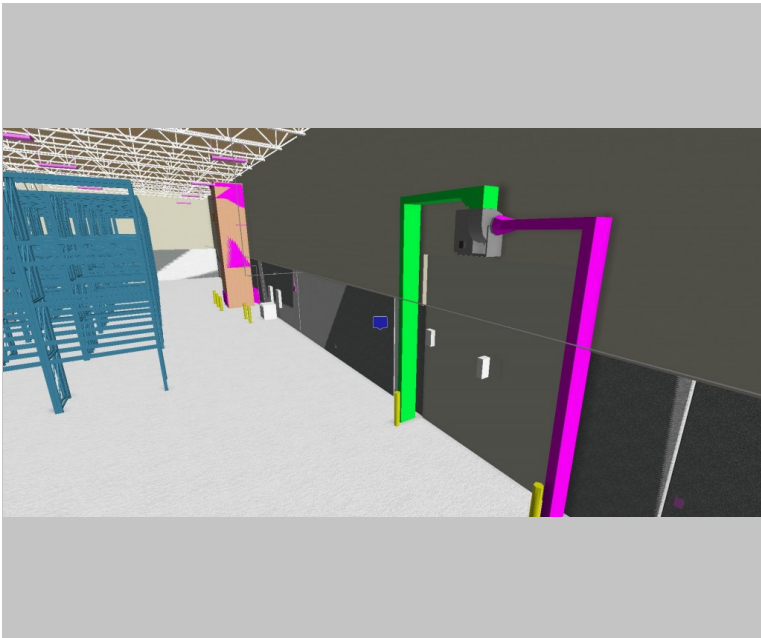
ID [24](#)

Title
Moving area(108) verify duct work placement against rolling door railings
